NEW YORK CITY TRANSIT RIDERS COUNCIL

Unwelcome Mats
New York's Subway Stations in Disrepair

August 2008

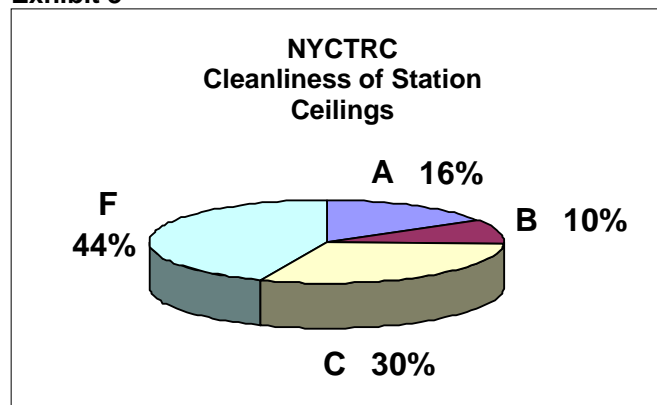
Exhibit 3

Station Ceilings are by far the worst areas of stations. The pervasive peeling and cracked paint is a condition no doubt related to chronic leakage problems. Twenty-two stations were given a failing grade and another 15 were only considered fair. It is acknowledged that Ceilings may be the most difficult portions of subway stations to maintain, with many areas rendered inaccessible due to pipes and electrical conduits. However, as ceiling conditions were often much worse than a station's condition as a whole, they can constitute a sore point in users' perception of station quality.

Platforms scored the worst of the three types of station areas, but ceiling conditions in Entrances and Control areas were only marginally better.

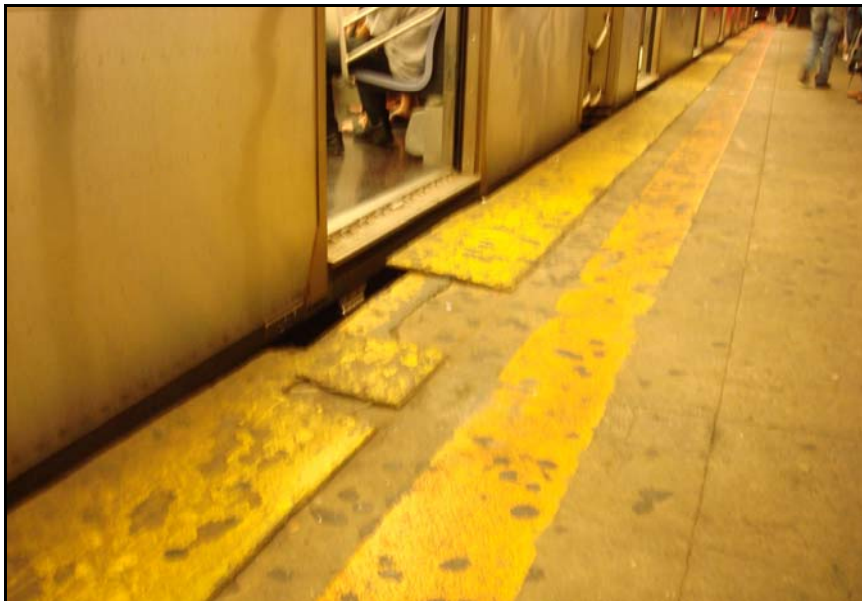
138th Street Grand Concourse

- 111th Street (A)
- 138th Street-Grand Concourse
- 149th Street-Grand Concourse (4)
- 50th Street (C,E)
- 71st Street
- 75th Street
- Avenue P
- Avenue X
- Bay Ridge Avenue
- Forest Avenue
- Fort Hamilton Parkway (D,M)
- Grant Avenue
- High Street/Brooklyn Bridge
- Knickerbocker Avenue
- Ozone Park/Lefferts Boulevard
- Steinway Street

- **Repair or replace deteriorated tactile warning strips in all stations.** It is important to note that 16 of the 50 stations surveyed did not have any warning strips. Tactile warning strips have proven to be an important safety initiative, not just for the visually impaired community, but for all users of the subway system.

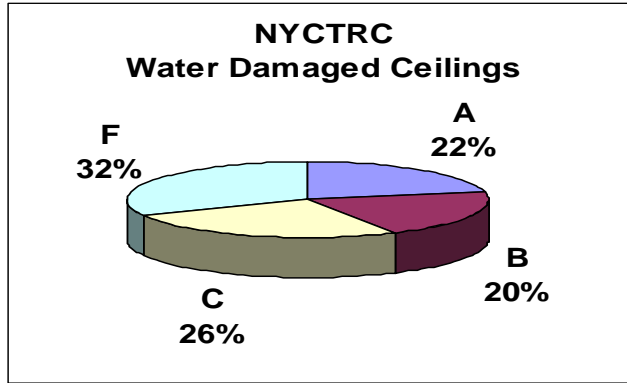
Exhibit 5

Water Leakage on Ceilings is an acknowledged serious problem that is difficult to solve. Sixteen stations (32%) were rated “F” and another 26% had moderate leakage. Damage was worst in Platform areas and in Entrances.

- **Because the poor condition of infrastructure in stations is substantially due to water damage, the Council strongly urges NYC Transit to create a “Water Intrusion Taskforce”.** This Taskforce should investigate the range of causes (why and who) and research possible solutions, including new technology that could be incorporated into station renovations.

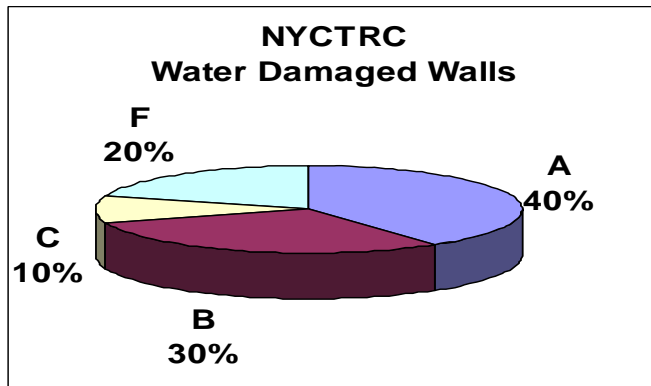
Exhibit 6

Water leakage on walls was more of a problem than water on floors. Ten stations were cited for unacceptable conditions, while five stations showed moderate water leakage on walls. Platforms had the most problems, with twice the level of problems of Entrances or Control areas.
