***New York City Transit Riders Council
Bus Stop Signage Survey***

DESTINATION: UNKNOWN

November 17, 1998

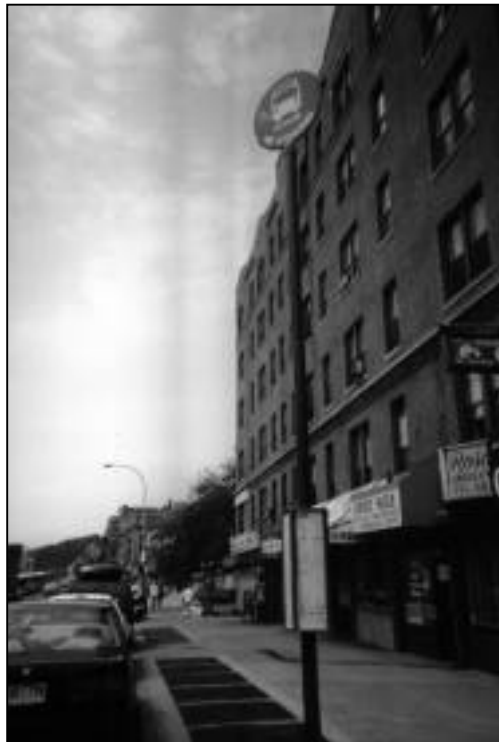
On the cover: A bare signpost on Broadway, near the corner of Isham Street, in upper Manhattan. Missing are route and destination panels for the southbound M100, Bx7, and Bx20 buses.

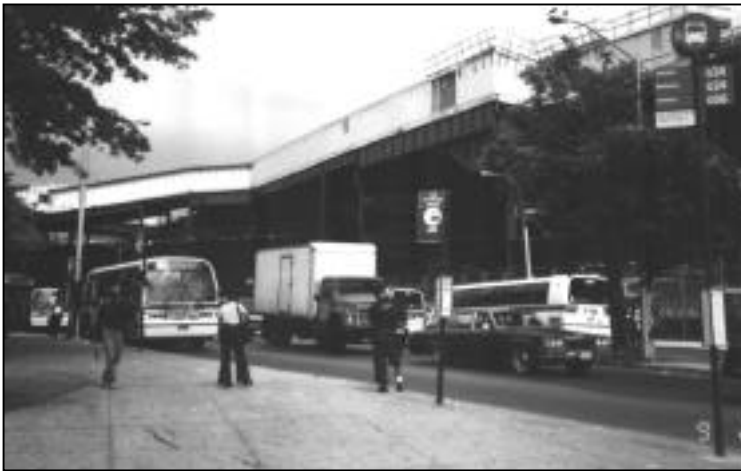
In the far left corner of this photo, the Q24 bus can be seen stopping at its correct stopping location at **Van Sinderen Avenue and Fulton Street in Brooklyn**. In the far right corner of the same photo, its new bus stop sign has been installed one-hundred feet out of place. When we visited this location, we were told by an NYC Transit employee that customers frequently wait at this incorrect location and miss the bus.

In the photo at right, one can also see that destination panels for both eastbound and westbound Q24 service have been installed. However, westbound service does not stop here.

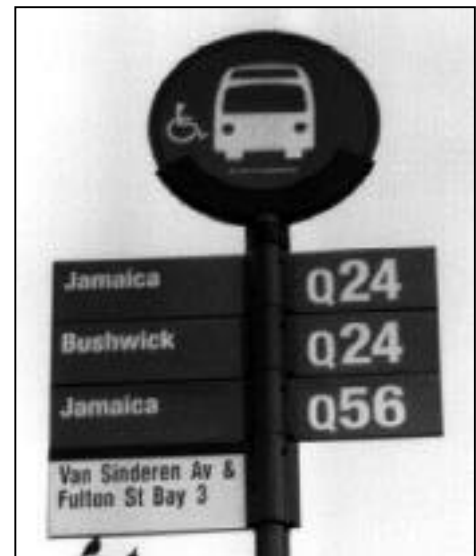
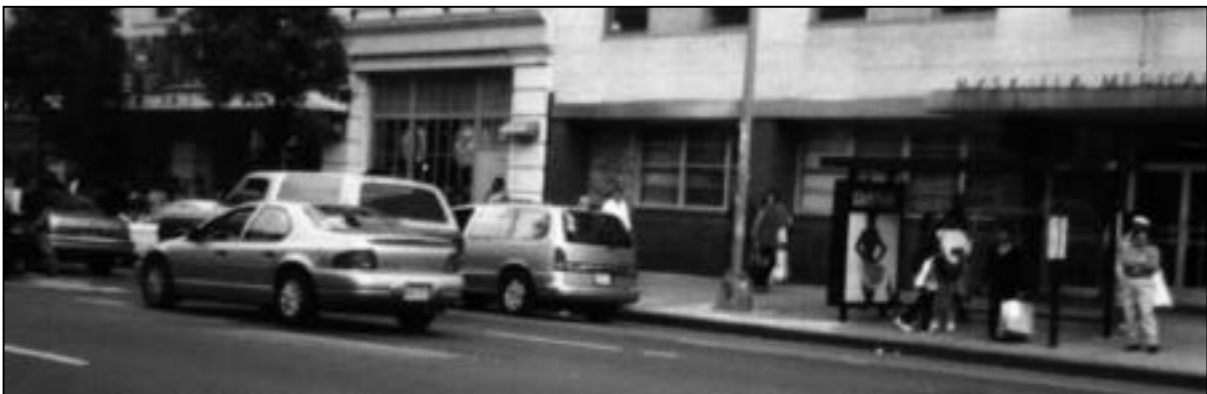
In the photo below, passengers wait at the bus shelter on **Sixth Avenue mid-block between 17th and 18th Streets in Manhattan**. The bus stop sign, however, has been installed near the corner of 18th Street, between the two trees in the far left corner of the photo. Because of its placement, the sign is not visible from the shelter.

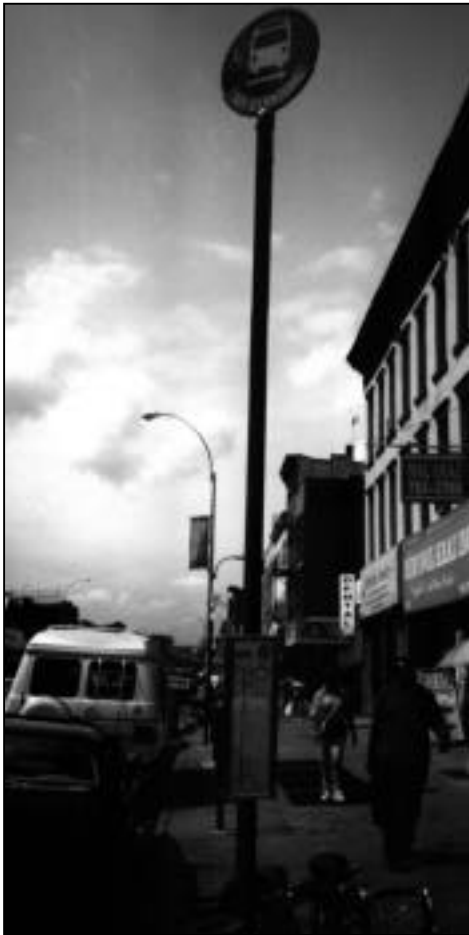
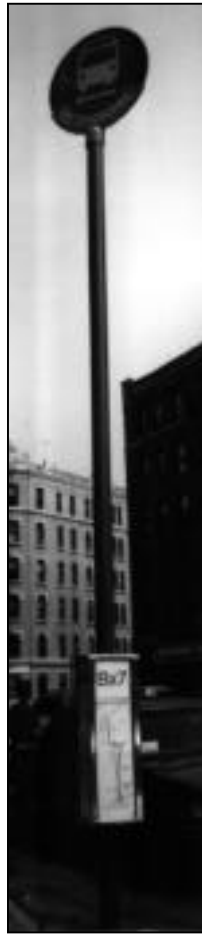
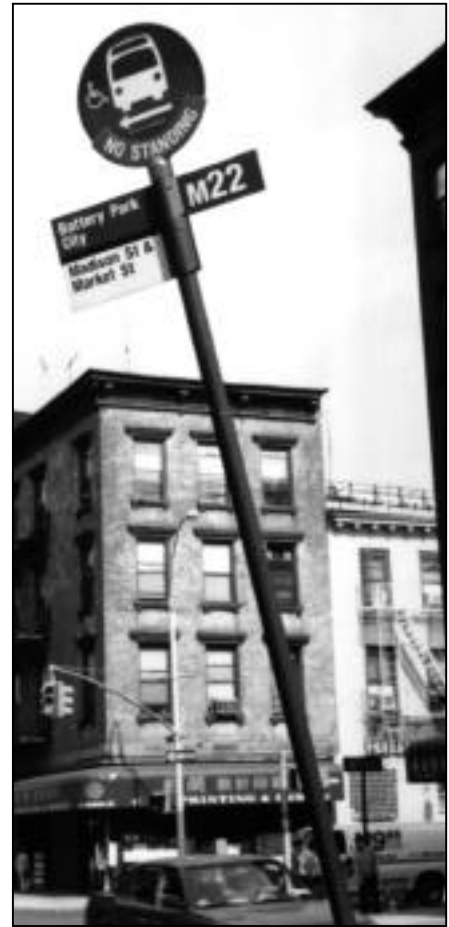
The signposts above left (**Fulton Street and New York Avenue in Brooklyn**) and center (**Broadway and West 228th Street in Manhattan**) are bare. They have been installed without any signage, although they do contain Guide-A-Rides.

The signpost above right, at the corner of **Madison and Market Streets in Manhattan**, has obviously been damaged by a vehicle collision and is in need of repair.

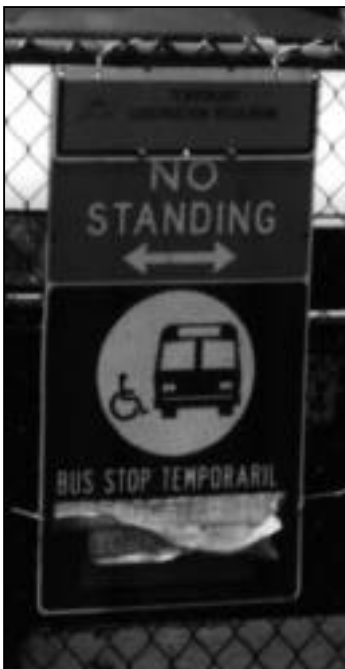
The temporary stop sign at left was found at **Twelfth Avenue near West 42nd Street in Manhattan**, the western terminal for the M42 and M50 routes. The new signpost was removed due to construction. This sign is not clearly visible to pedestrians, has part of a message showing which is not intended for this location (“Bus Stop Temporarily Relocated to York Avenue...”) and does not list the routes which serve the stop. As a result, the many tourists who utilize the M42 and M50 routes to access waterfront attractions have difficulty finding the stop for their return trips.

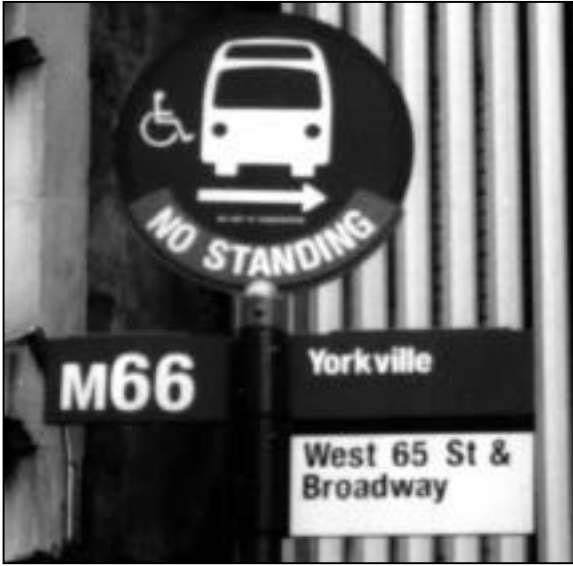
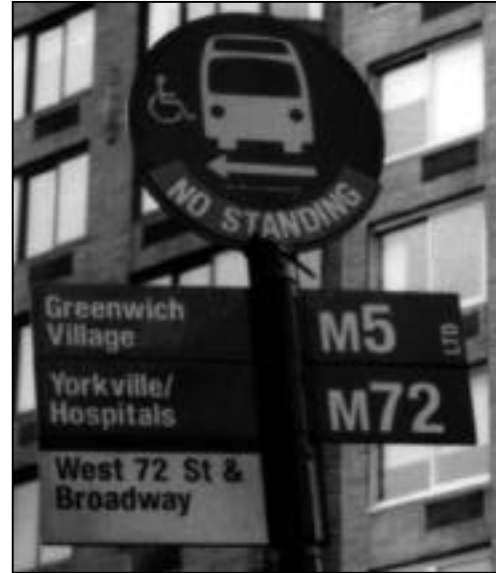
The above signs, located on **Manhattan's Upper West Side**, list Yorkville as the destination for the eastbound M66 and M72 routes. However, Yorkville, a neighborhood on the Upper East Side, begins at 79th Street, one-quarter mile north of the M72 and fully one-half mile north of the M66. These destination signs should read, simply, Upper East Side. Furthermore, the M66 serves the same Upper East Side hospitals as does the M72.

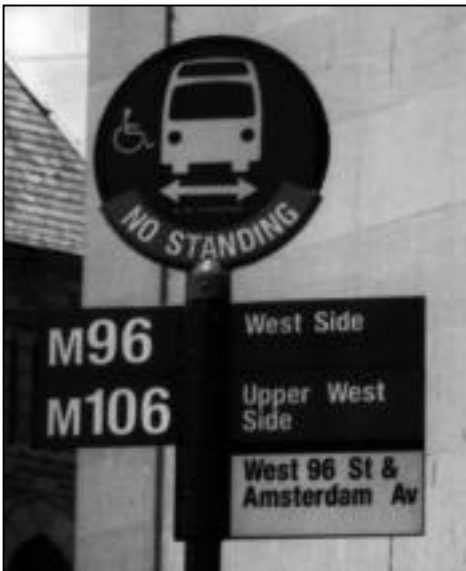
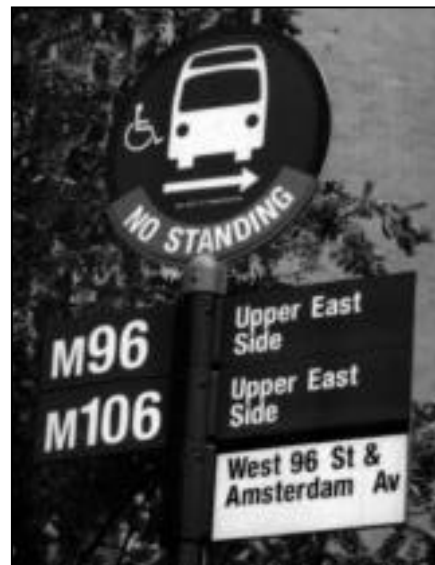
The sign below left lists West Side as the westbound destination for the M96. The correct destination is Upper West Side.

The sign below right lists Upper East Side as the eastbound destination for the M106 bus, which runs along East 106th Street. However, east of Central Park this bus runs entirely in Harlem.

Unlike the Upper West Side, which extends north to 110th Street, the Upper East Side definitively ends at 96th Street.

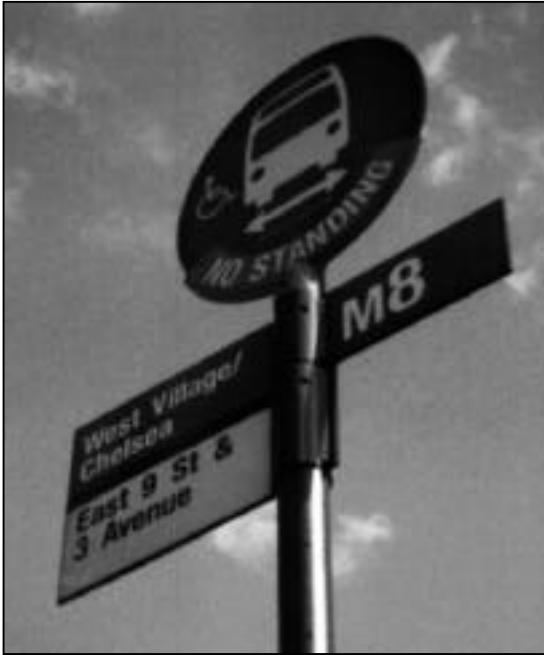
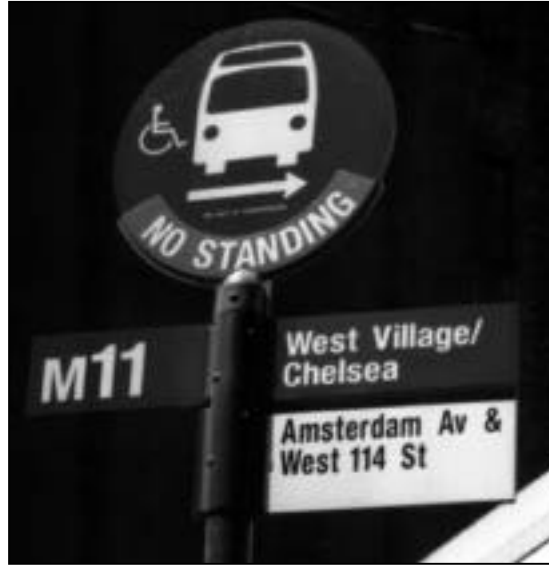
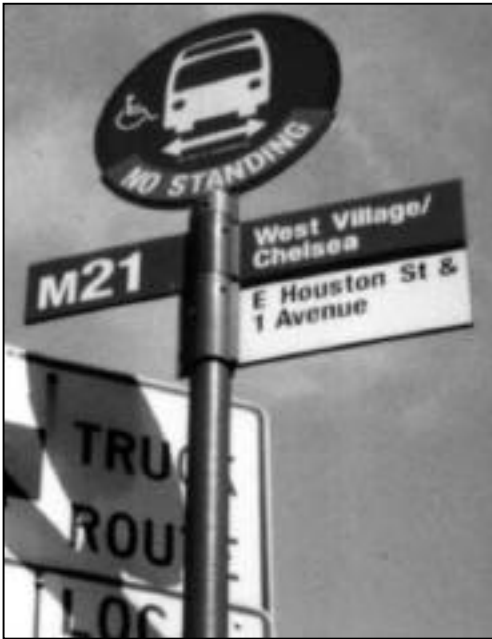
These three **Manhattan** signs confuse the neighborhoods of Chelsea and the West Village with each other. However, they are different neighborhoods, separated by West 14th Street. Of the routes listed, *none* terminate in Chelsea, and only one, the M11, passes through the neighborhood.

Furthermore, one of these routes, the M21, does not terminate in either neighborhood. The M21 serves Houston Street, at the southern border of Greenwich Village. However it terminates on Spring Street, in SoHo.

The correct destination panels should read: M8-West Village; M11-West Village; and M21-SoHo.

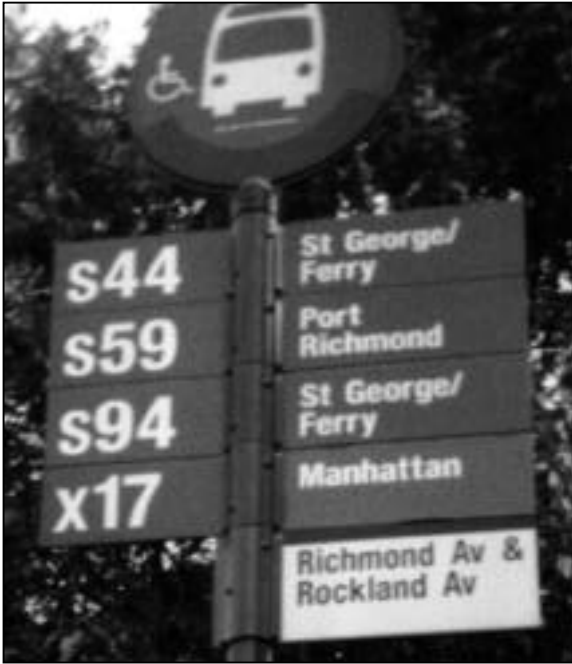
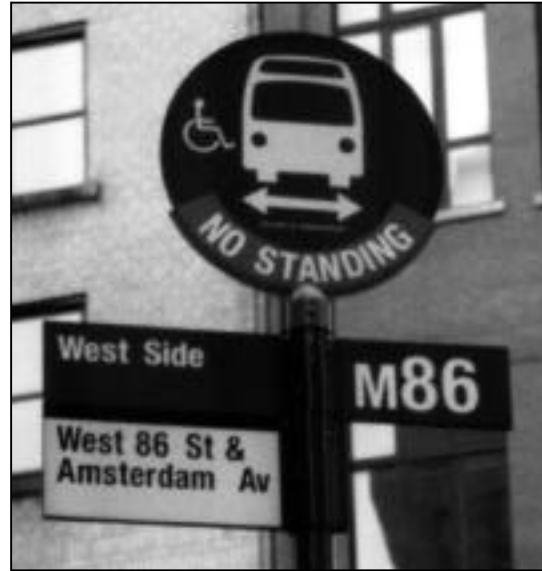
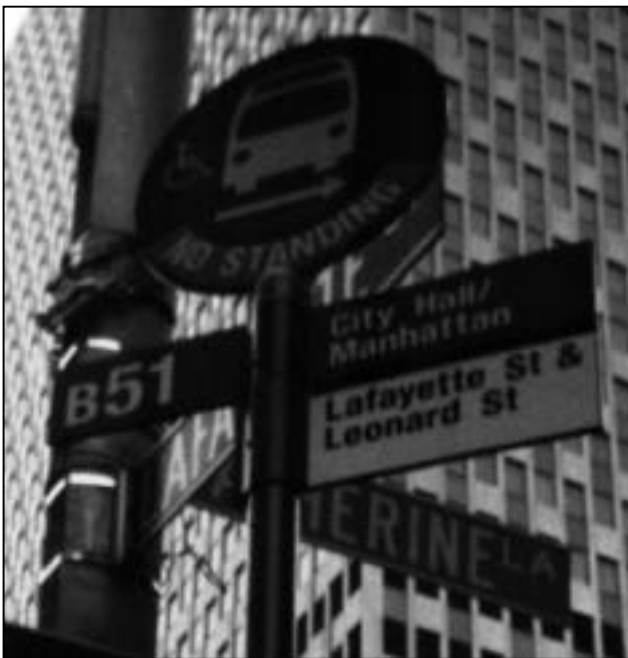
The **Staten Island** signpost, above left, lists, simply, Manhattan, as the destination of the X17 Express route. However, all Express routes terminate in Manhattan. It would be more useful for customers if this sign listed where in Manhattan this route terminates. In fact, all of the destination panels in this section of examples would be more helpful to customers if they included final street destination information.

The **Manhattan** signpost, above right, lists West Side as the destination of the westbound M86. The correct destination should read Upper West Side. But the signpost is located on the Upper West Side. It would be more helpful for a street destination to be listed.

There is no reason for a signpost in **Manhattan**, above, to include Manhattan on its destination panel. City Hall by itself would suffice.

The signpost at **Seventh Avenue and West 34th Street in Manhattan**, at right, has its destination panels reversed. The M16 serves the Port Authority Bus Terminal. The M34 serves the Javits Center. Further, neither bus serves the 42nd Street Pier.

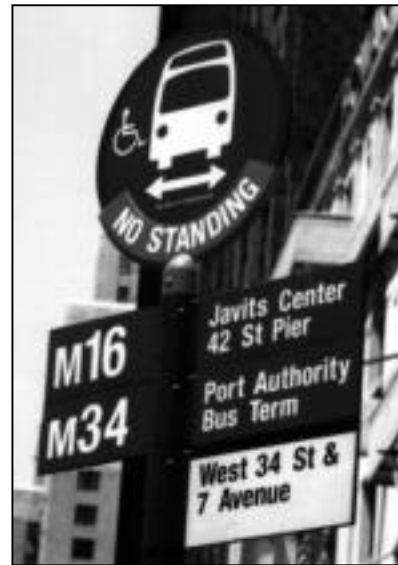
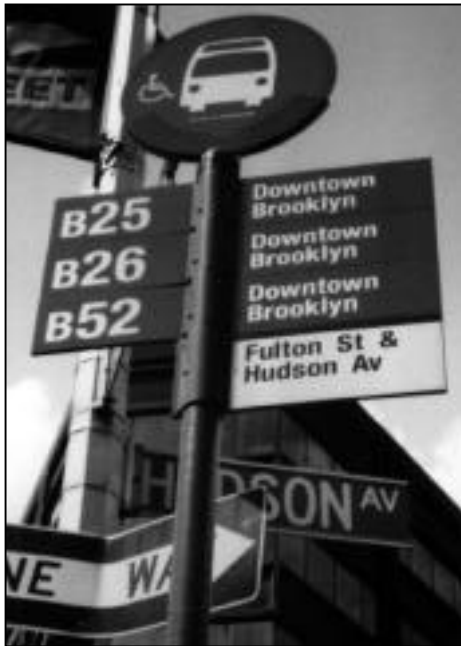
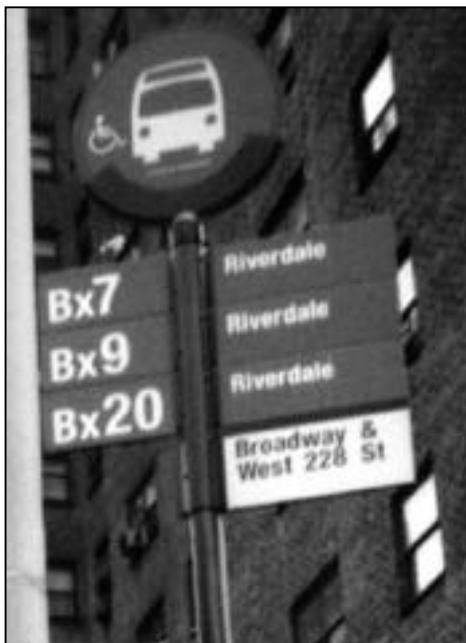
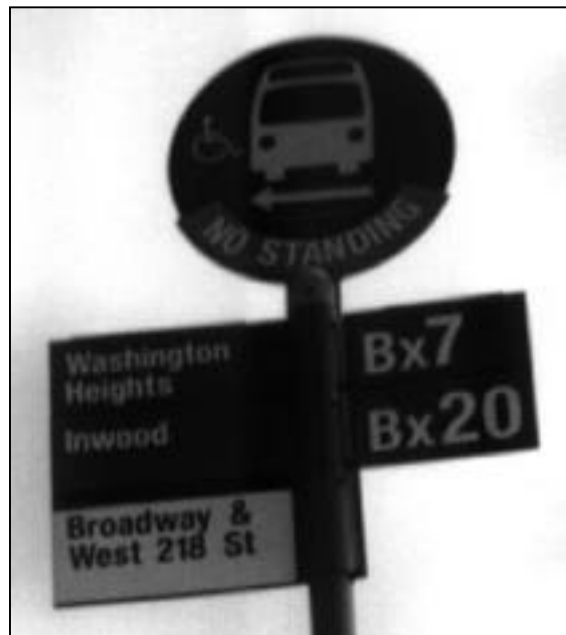
The signposts in **Downtown Brooklyn**, at left, **Riverdale**, below left, and **Inwood**, below right, list the very neighborhoods in which they are located as destinations on some routes. Customers boarding at these stops know the end of the route is near. But they cannot tell how near. Any of these stops may be the last stop, or the first of many in some large neighborhoods. Such destination panels should list terminal street intersections, and should clearly indicate when they are located at the last stop of a route.

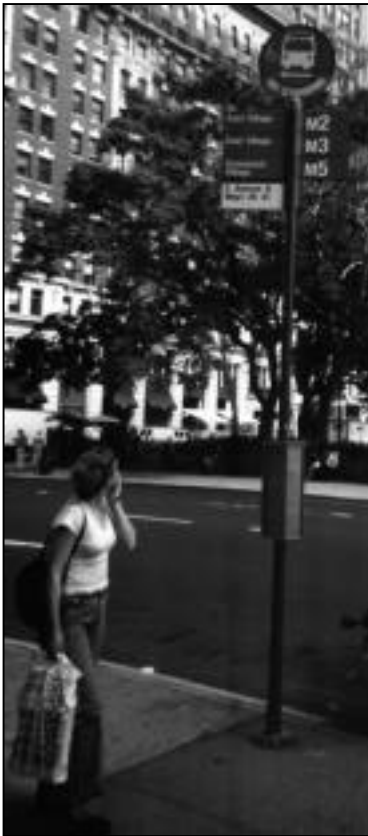
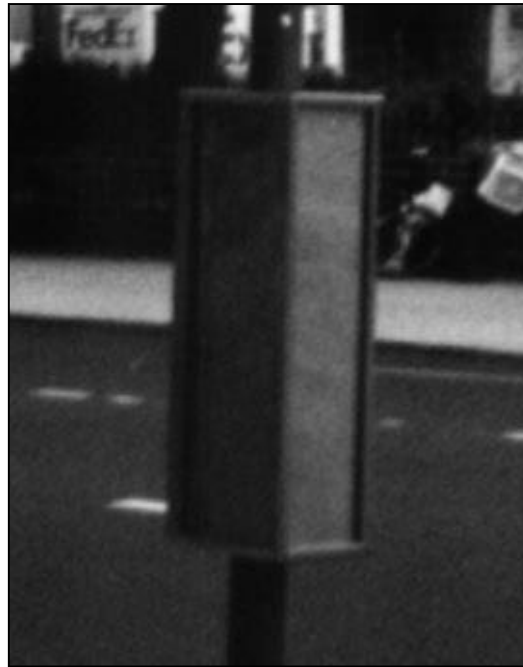
Why does the woman at left appear confused? Perhaps because the bus stop at which she is standing contains an empty Guide-A-Ride canister (above). The signpost, at the corner of **Fifth Avenue and West 26th Street in Manhattan**, is also missing route and destination panels for the NYCDOT contract carrier BxM11.

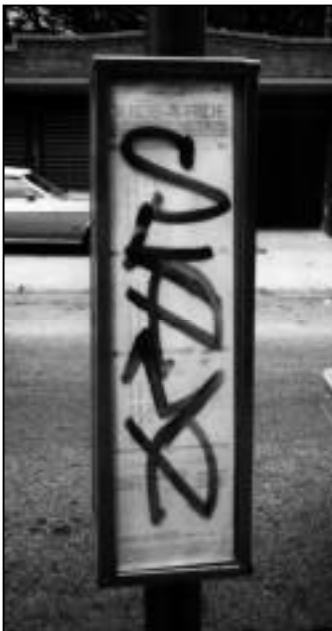
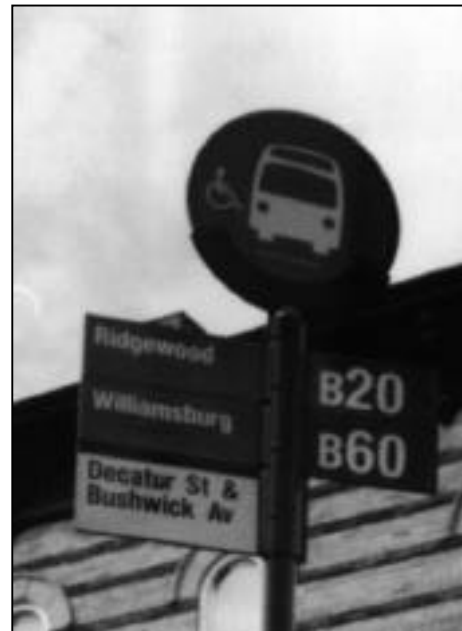
The Guide-A-Ride schedule at left, from a signpost at **Decatur Street and Bushwick Avenue in Brooklyn** (right), is illegible due to graffiti.

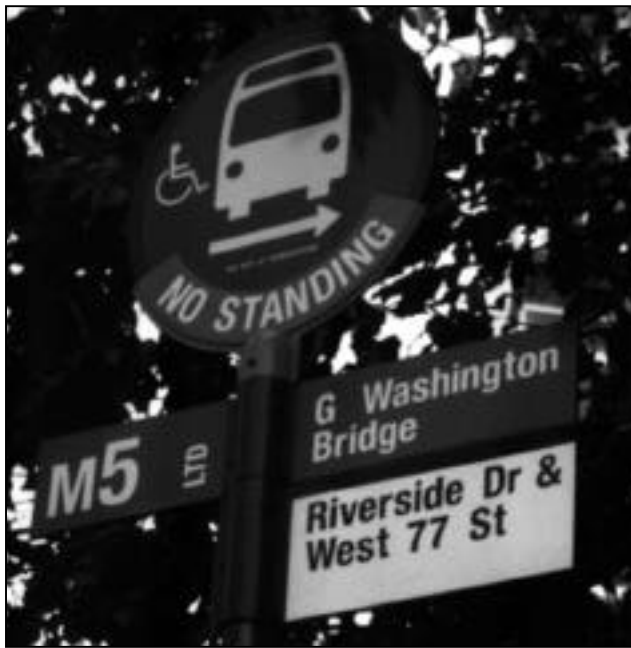
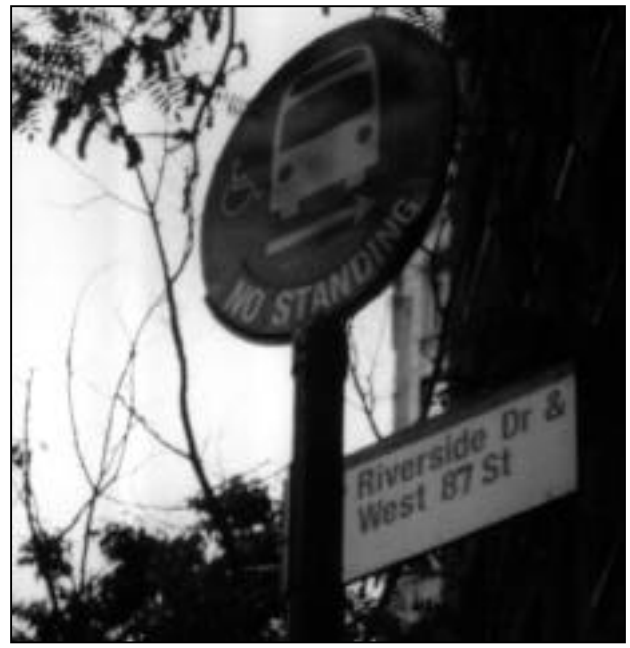
The M5 sign on **Riverside Drive**, above left, is a Limited route sign, but all service on Riverside Drive is Local. Above right, all route information panels are missing from another M5 Riverside Drive signpost.

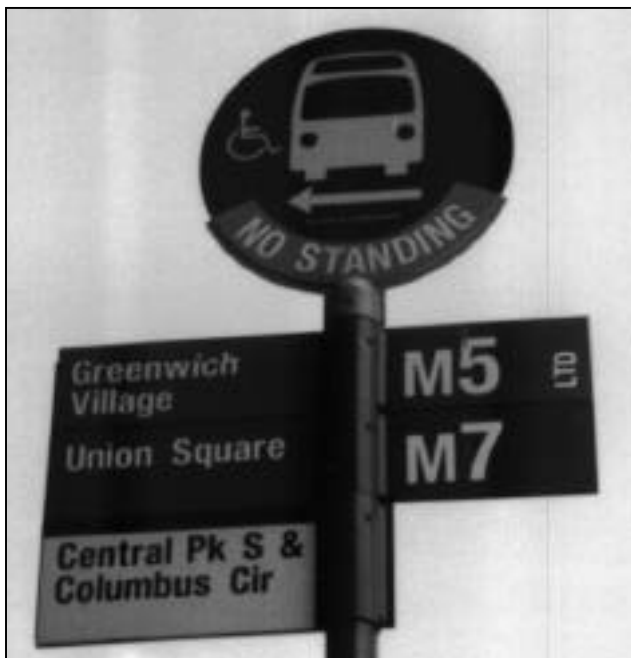
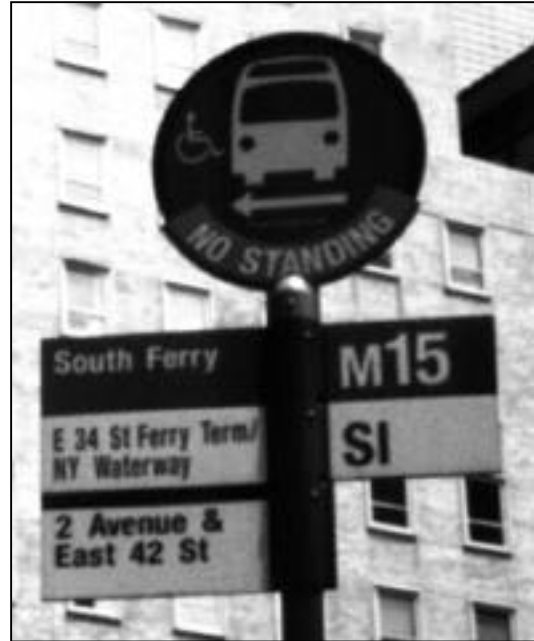
Following NYC Transit guidelines, the signpost at **Central Park South and Columbus Circle**, below left, lists only Limited service at this M5 route Limited stop, thus customers have no way to discern that M5 Local service is available here weekday evenings and weekends. Meanwhile, the signpost at **Second Avenue and East 42nd Street**, below right, incorrectly lists only Local M15 service at a Limited stop served by both types of service.

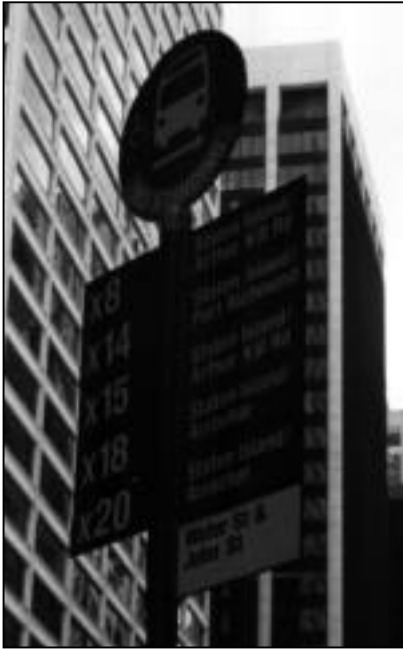
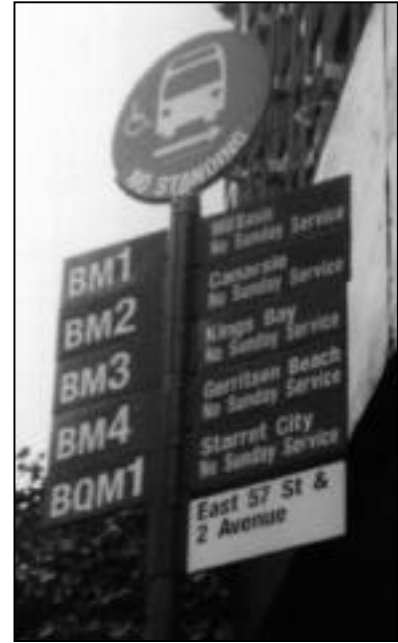
Both of these Express route signposts are in **Manhattan**. The signpost on the left lists NYC Transit Express routes and follows the NYCT policy of not including Hours-of-Operation information on destination panels. However, Express routes run only during certain hours, and some of them make different stops at different times of day. The more useful signpost on the right lists NYCDOT contract carrier Express routes and does contain Hours-of-Operation information.

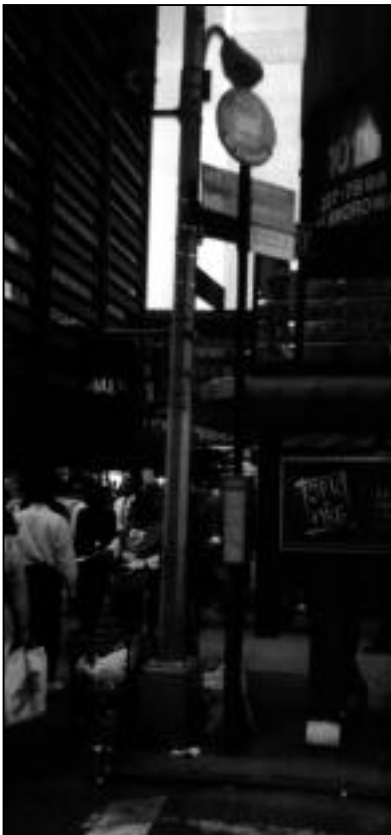
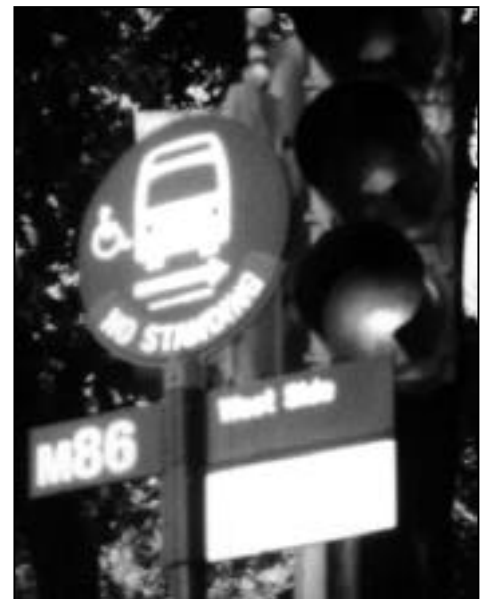
The signpost at left, at the corner of **Broadway and Cortlandt Street in Manhattan**, is misplaced 15 feet from the actual bus stop location, on the other side of a telephone booth. Its Guide-A-Ride cannot be easily or safely read because the location of the signpost, wedged between telephone booth, streetlamp, and curb, obscures one side of the Guide-A-Ride and forces customers to stand in oncoming traffic to read another. The signpost also obscures the Broadway street sign.

The signpost at right, in the **86th Street Transverse in Central Park**, is blocking a traffic signal. Its destination is also incorrect. The westbound M86 goes to the Upper West Side.

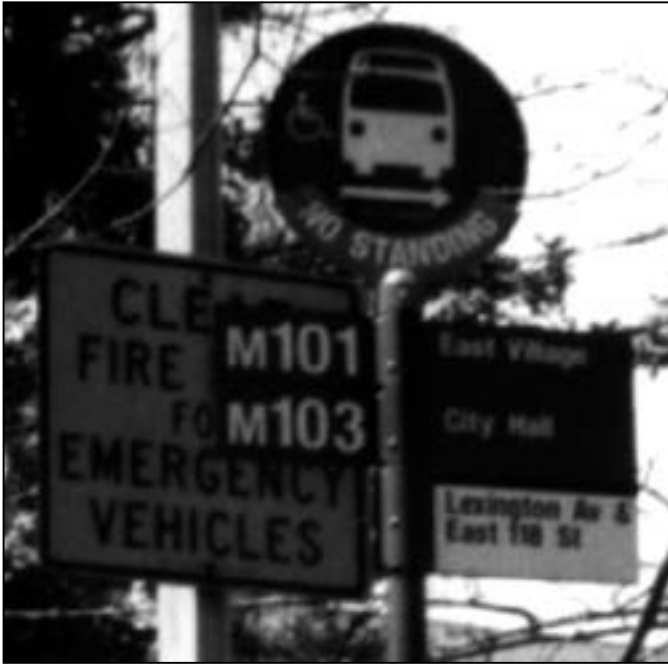
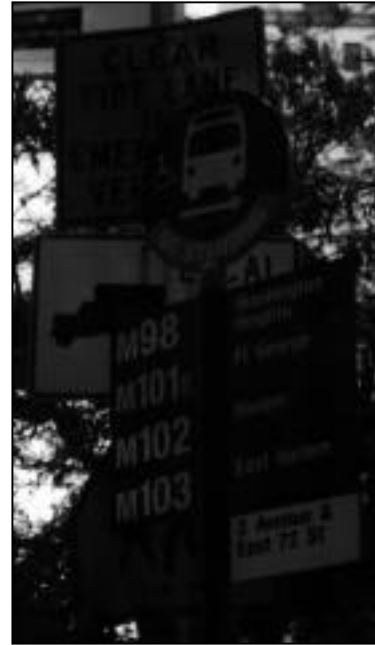
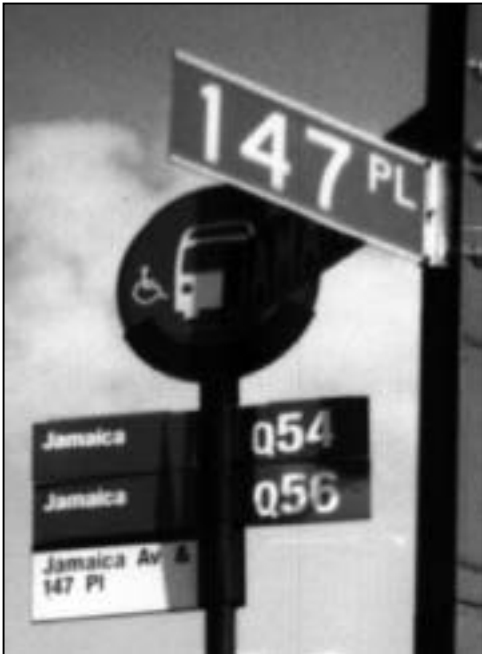
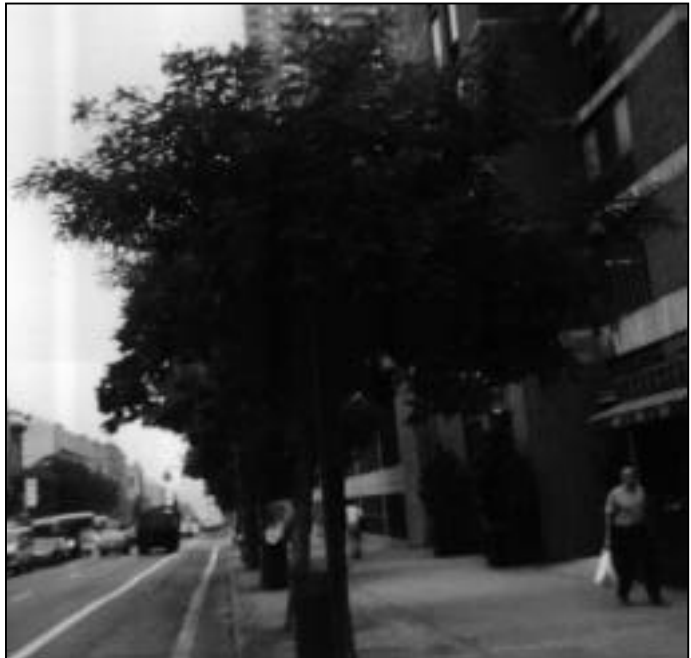
The signposts at **Lexington Avenue and East 118th Street in Harlem**, above left, **Third Avenue and East 72nd Street on the Upper East Side**, above right, and **Jamaica Avenue and 147th Place in Jamaica, Queens**, below left, all block street signage, and are obstructed by this same signage from the opposite side.

The signpost below right is on **West 42nd Street near the corner of Ninth Avenue**. It was installed in winter too close to a tree. Now that the tree has bloomed, the signpost is all but invisible.
